## Sebalog HydroCorr

### Correlating noise loggers with hydrophone sensors

Leak location in a DN 900 grey cast iron water main

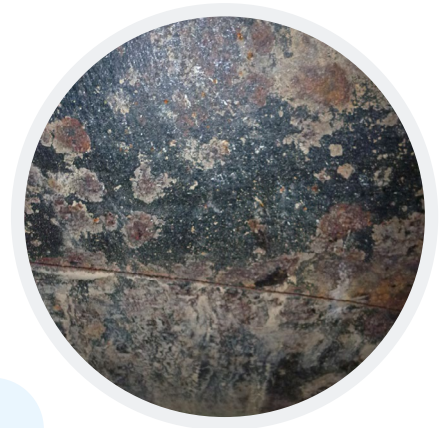
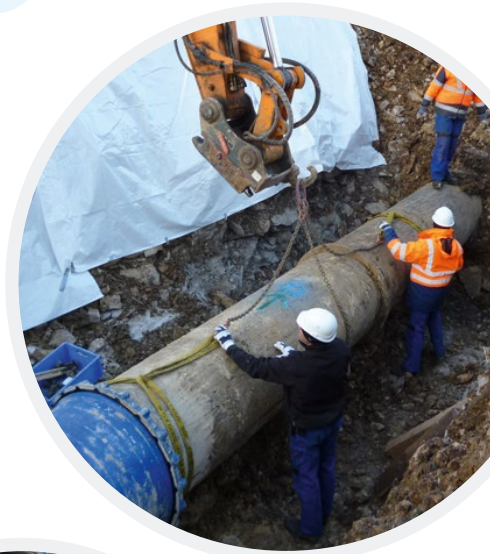
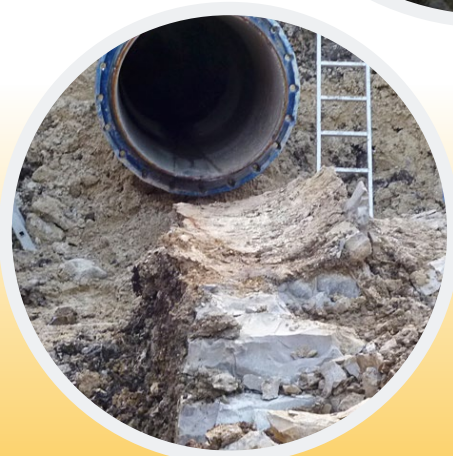
Although the pressure in the pipe was only around 1.5 bar, it was possible to carry out a successful measurement and receive a definite correlation result. The following pipe excavation confirmed the correlated leak location, revealing a 5 metre-long crack in the bottom of the pipe.
